Water Quality Assessment of Yamuna River for Its Impact on Durability of Concrete Structures along the Riverbed

Central Soil and Materials Research Station, CSMRS, New Delhi , India
Samyog78@yahoo.com

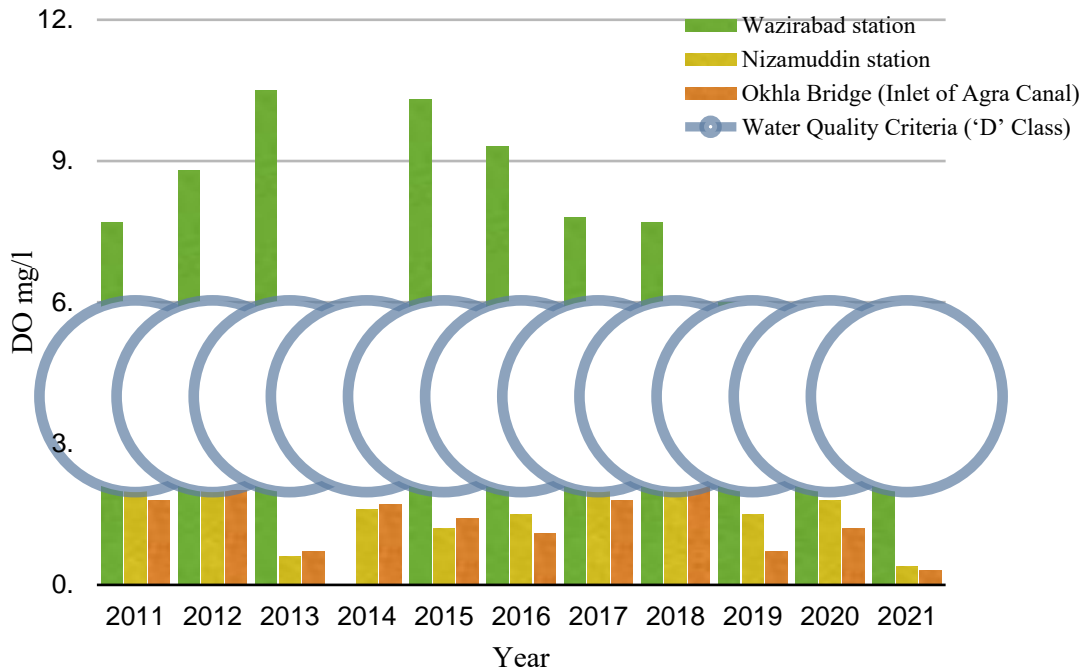
Figure 9. Concentration of DO within the Delhi Stretch of Yamuna River (2011-2021)

Results clearly shows the level of DO is decreasing downstream while BOD level increasing as moving downwards towards okhla barrage.

The Dissolved oxygen (DO) and Biochemical Oxygen Demand (BOD) values based on monitoring carried out between 2011 to 2021 are presented in fig. 9 & 10. The observation between 2011-2020 was presented from the literature review however CSMRS also conducted testing in the year 2021.
